TECHNICAL REPORT S-78-6

# INVESTIGATION OF CONSTRUCTION CONCEPTS FOR PAVEMENTS ACROSS SOFT GROUND

Geotechnical Laboratory  
U. S. Army Engineer Waterways Experiment Station  
P. O. Box 631, Vicksburg, Miss. 39180

July 1978

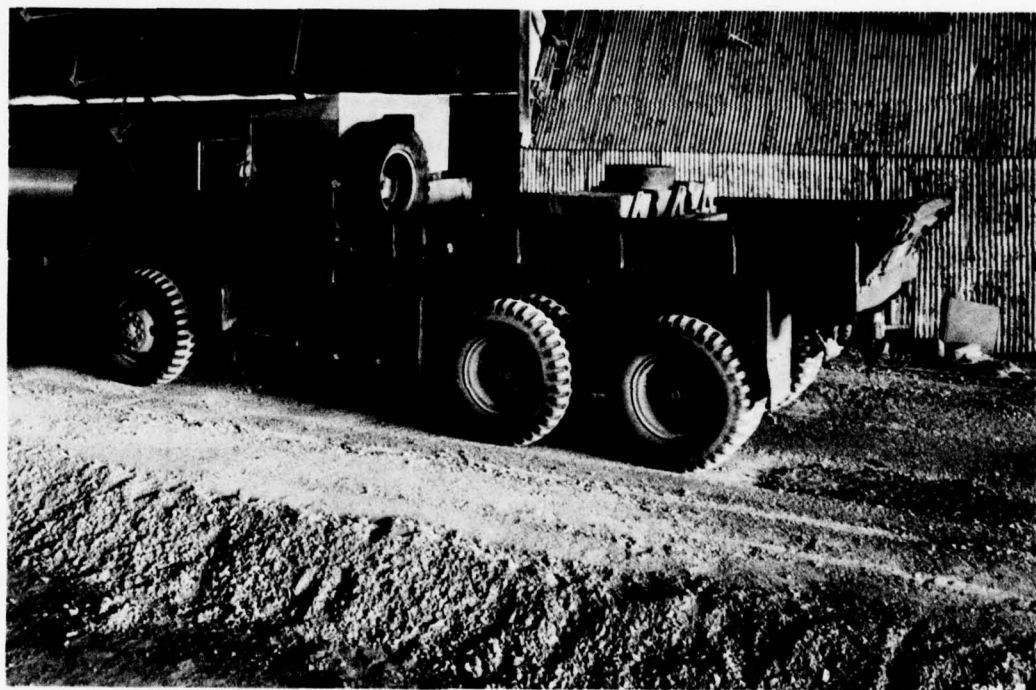
Figure 1. Military 5-ton, M54, tandem-axle cargo truck used for applying test traffic

27. Test traffic was applied during October, November, and December of 1976. Traffic was applied using the 5-ton tandem-axle military cargo truck shown in Figure 1. The 11 x 20, 12-ply tires were

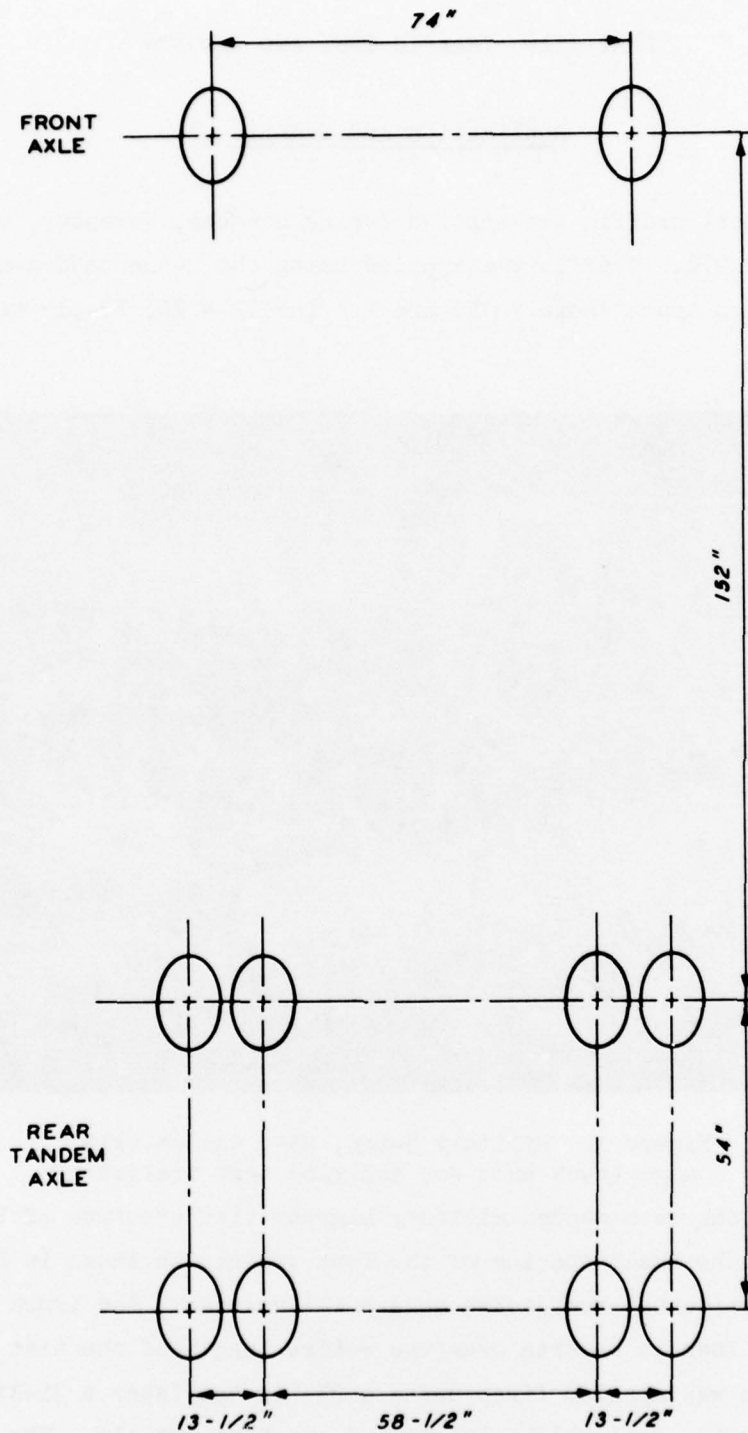
Figure 2. M54 cargo truck  
wheel configuration

inflated to the recommended military highway tire pressure of 70 psi. A layout of the wheel spacing of the test vehicle is shown in Figure 2. The test section was trafficked as a one-lane road. The truck was driven forward and then in reverse over the entire length of the test section. Test traffic was applied first using a 25-kip and later a 35-kip load on the tandem-axle, dual-wheel assembly of the test vehicle. The load on the front single-axle, single wheels of the test vehicle was 9.6 kips

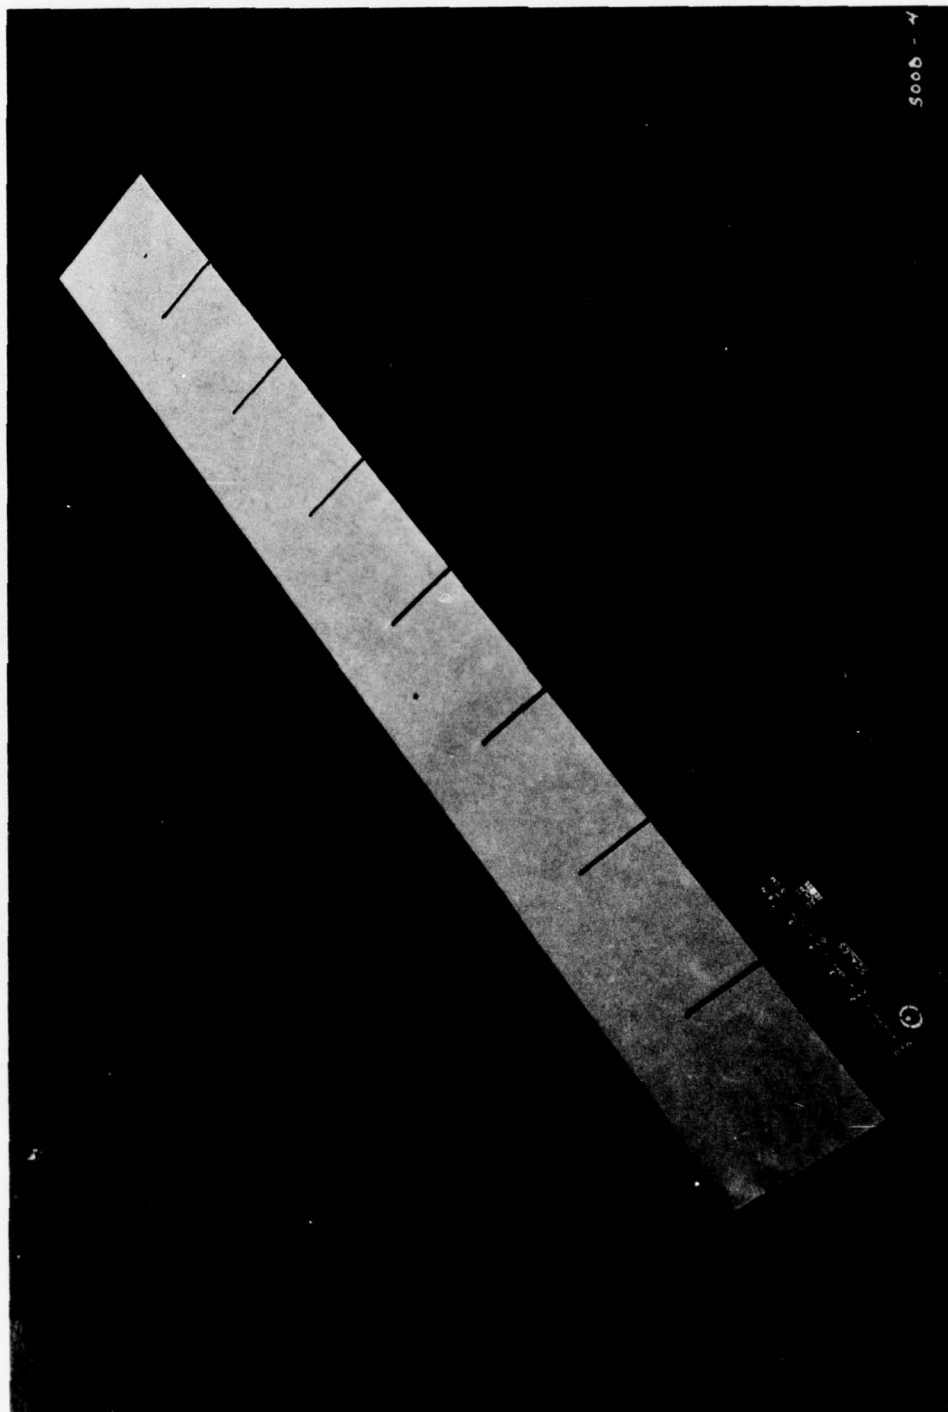
Photo 2. Aluminum grid panel

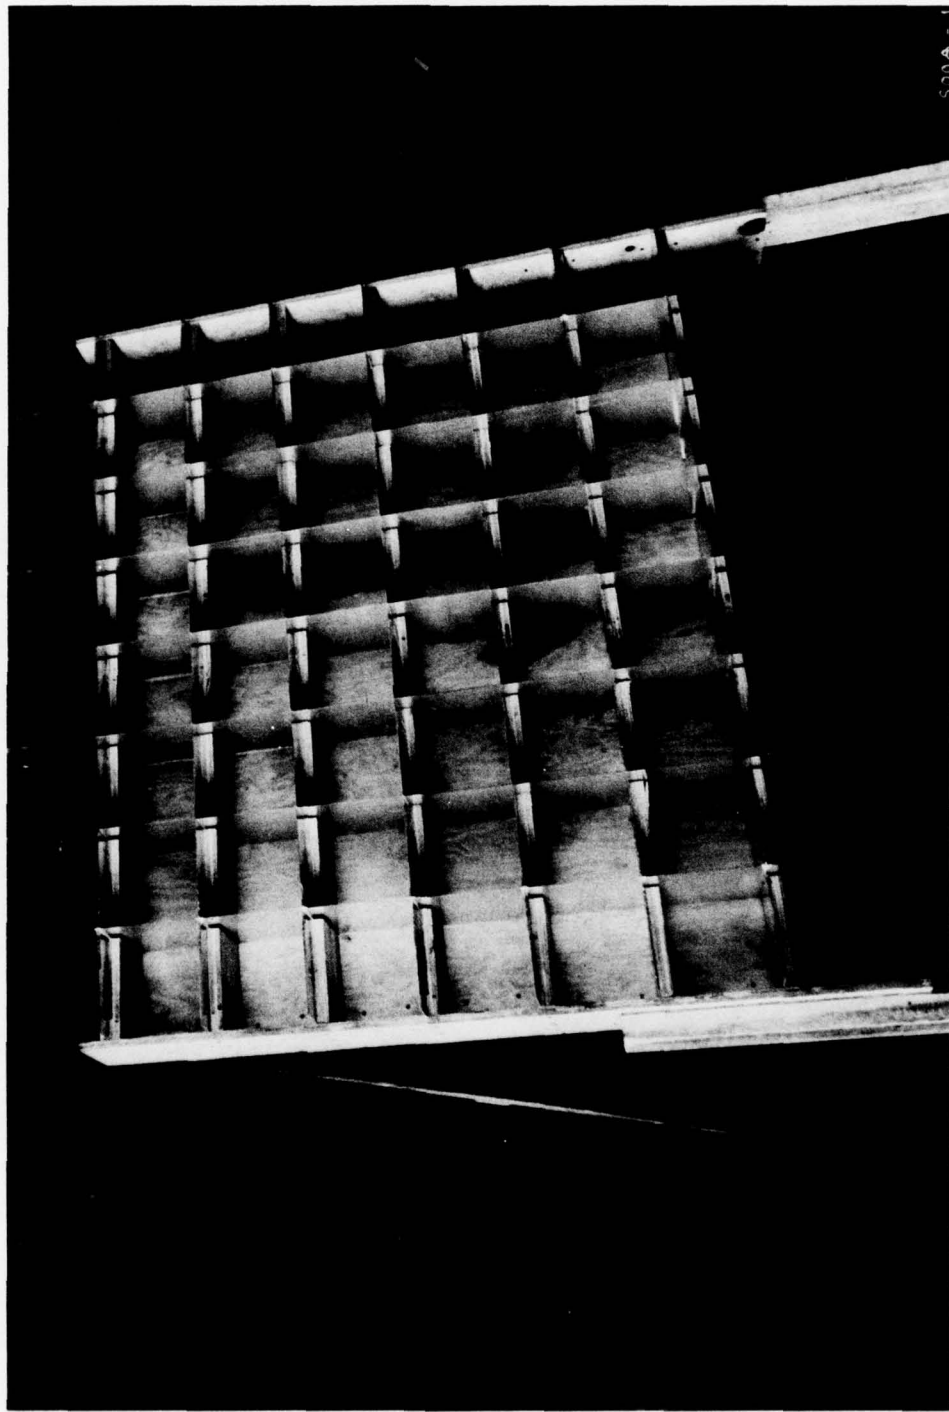
Photo 3. Assembling grid sections with aid of jig

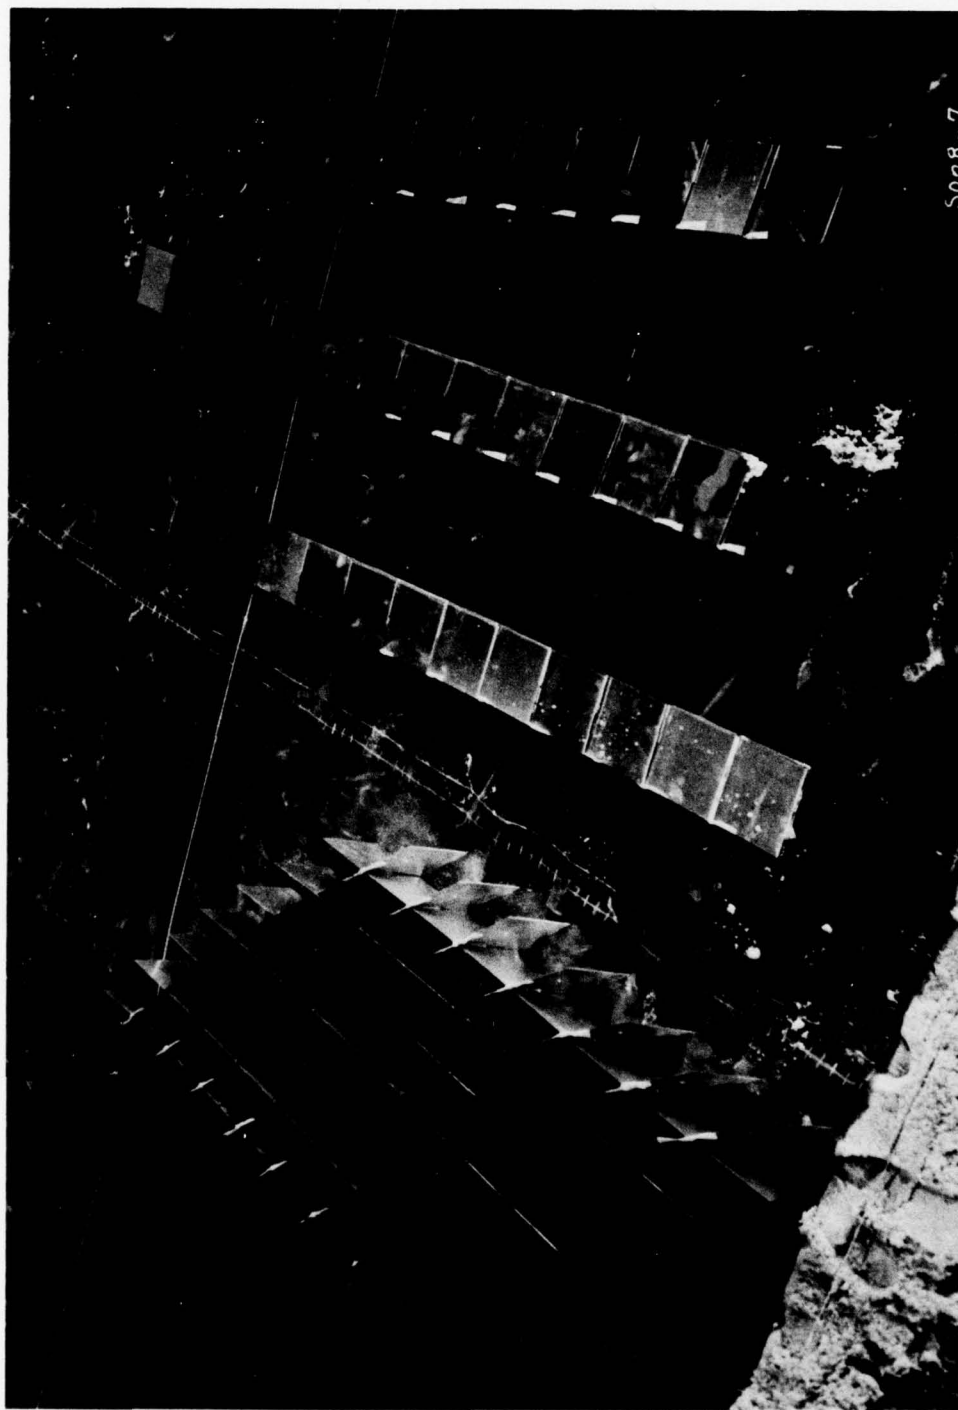
Photo 5. Grid sections folded for convenient storage and handling

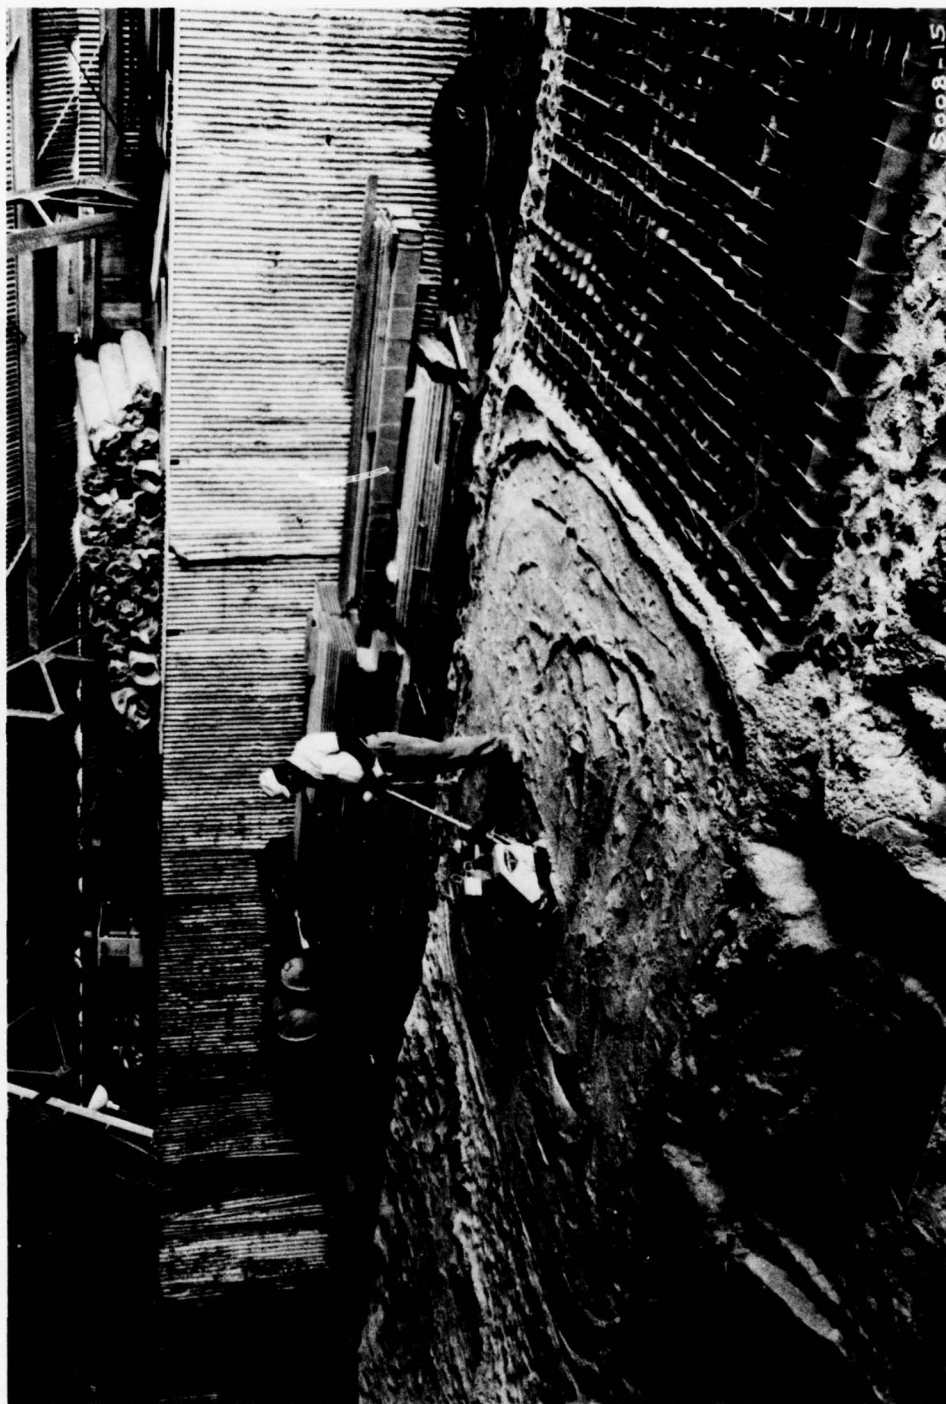
Photo 7. Compacting wet sand into grids using a vibratory plate compactor, items 1-3

vibratory plate compactor (Photo 7). The excess sand layer prevented damage to the grids during compaction. After compaction, most of the excess sand was removed, and another grid layer was placed on top of the one just installed. The top layer of grids was placed with a 3-in. offset (both directions) over the bottom layer of grids. The top layer of grids was filled and compacted with sand in the same manner as had been done for the bottom layer of grids. Photos 8 and 9 show the surface of the grids prior to placing the crushed stone wearing surface. The 2- to 3-in. crushed stone wearing surface was placed and then compacted by use of the vibratory plate compactor.

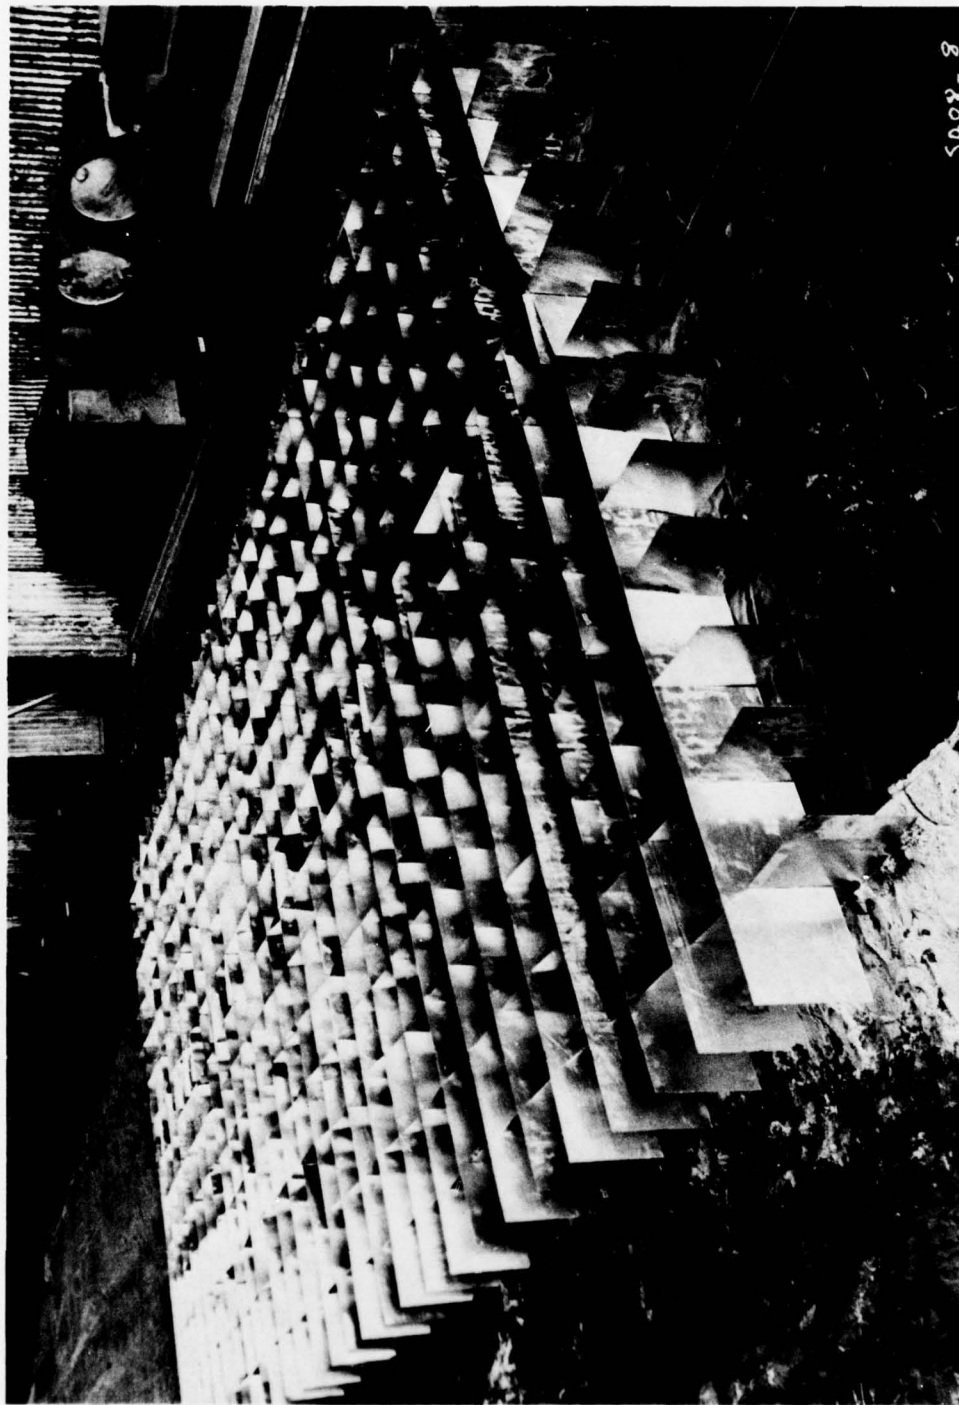
Photo 10. Installed layer of cubic 12-in. grids, item 4

23. T-16 membrane was placed directly on the subgrade and a layer of cubic 12-in. grids was placed on this (Photo 10). Mortar sand was used in the east half of the item and concrete sand in the west half. The sand and crushed stone wearing surface was placed and compacted as in items 1, 2, and 3.

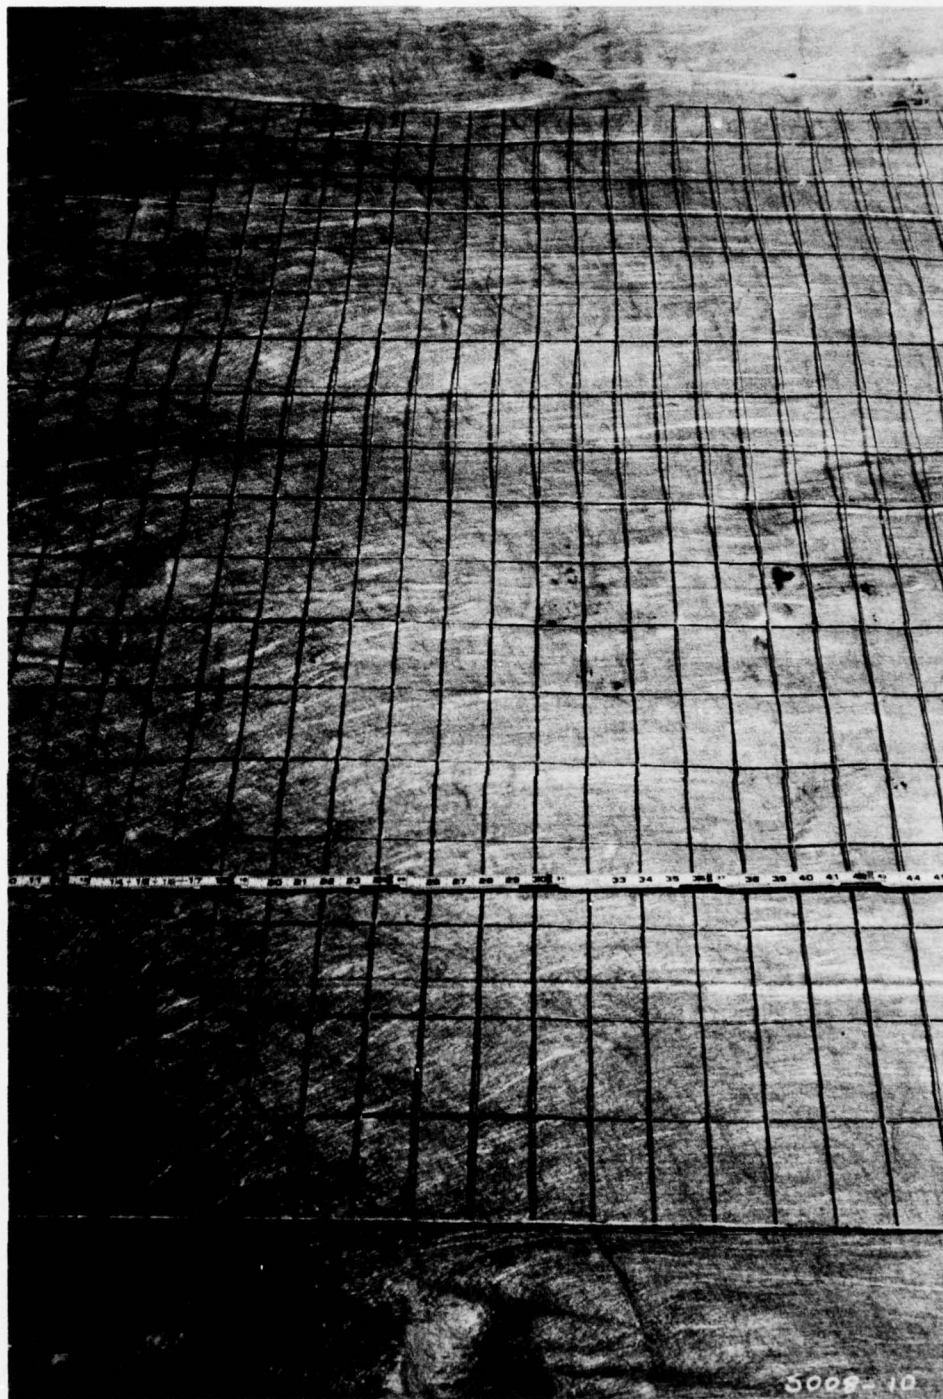
Photo 11. Wire-reinforcing material placed on top  
of polyester fabric in half of item 5

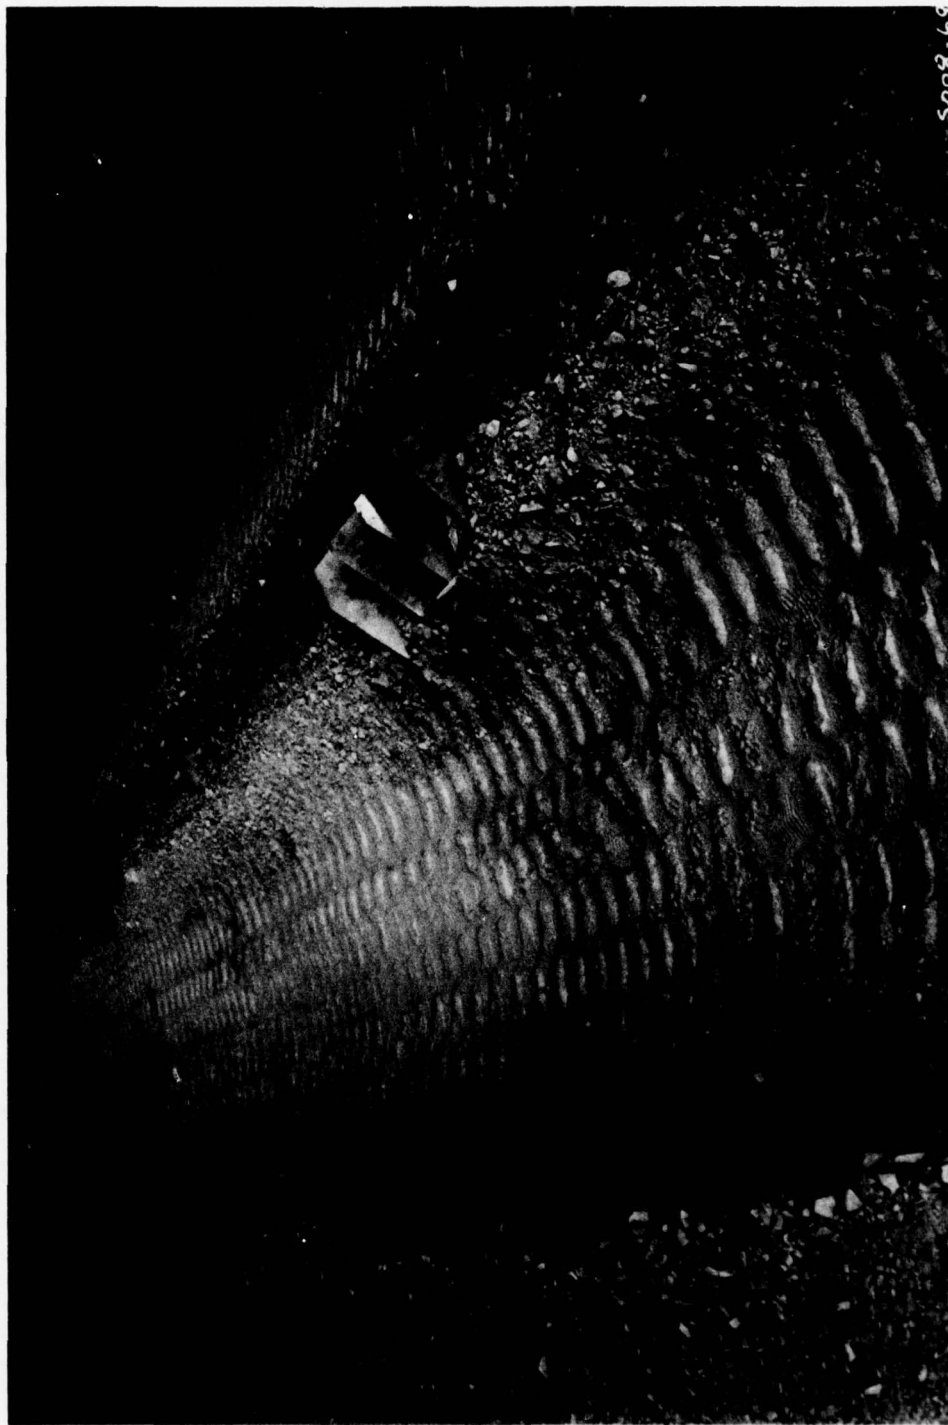
Photo 15. Closeup view of grid failure in west wheel path of item 1

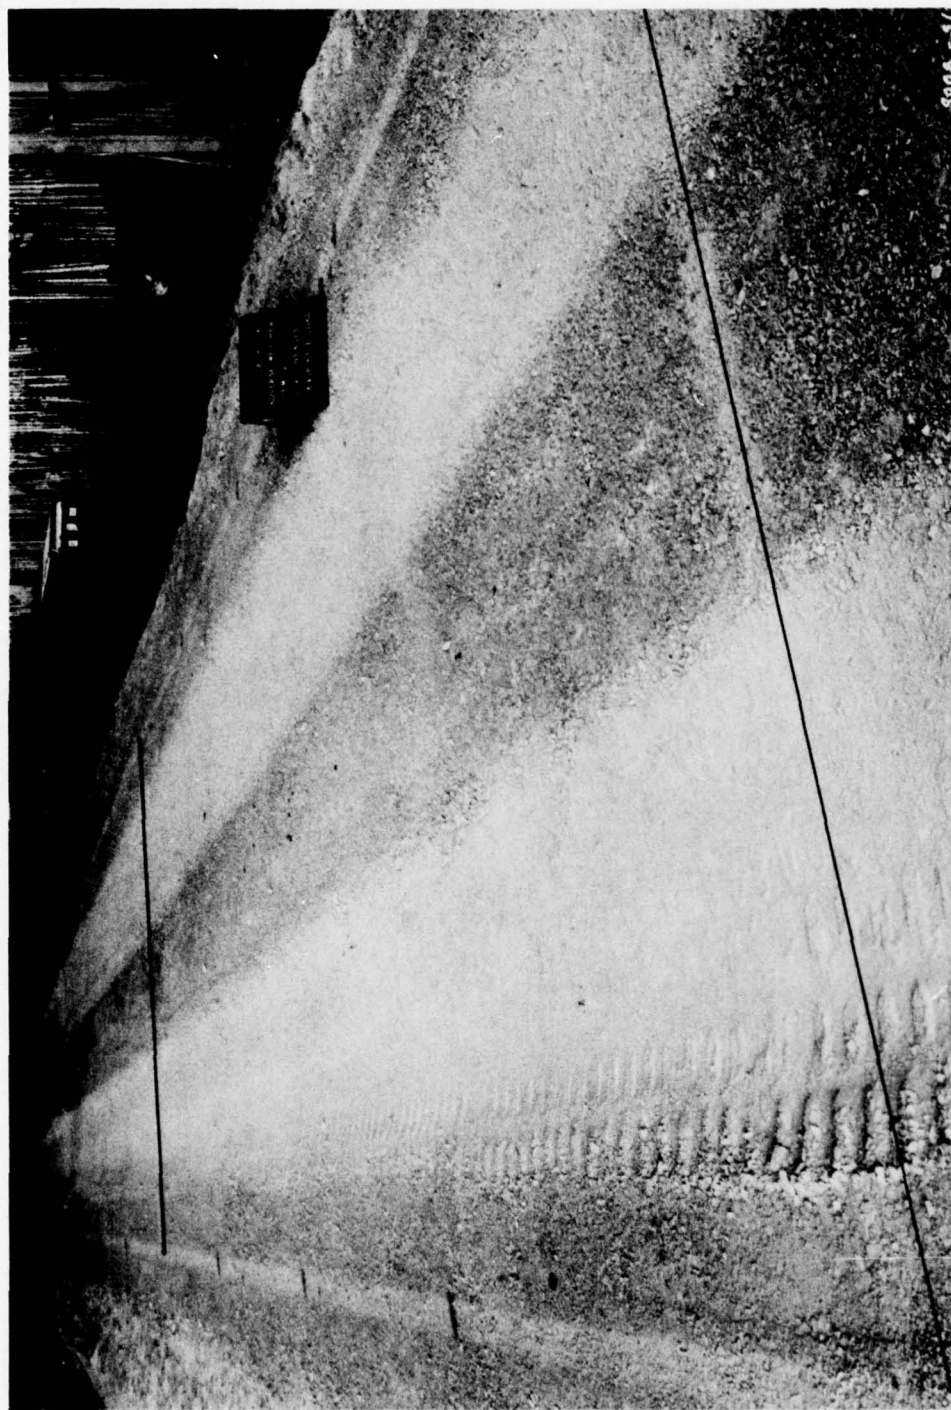
Photo 17. Item 2 after 259 coverages

32. The performance of item 2 was similar to, but slightly better than, that of item 1. Photo 17 shows the surface conditions at 259 coverages. The average rut depth was 1.1 in. in the east wheel path and 1.7 in. in the west. After 5899 coverages, the average rut depth in the east wheel path was only 2.8 in., but the rut depth in the west wheel path had increased to 6.4 in. By 6594 coverages, the west wheel path had failed, but the average rut depth for the east wheel path was only 3.3 in.

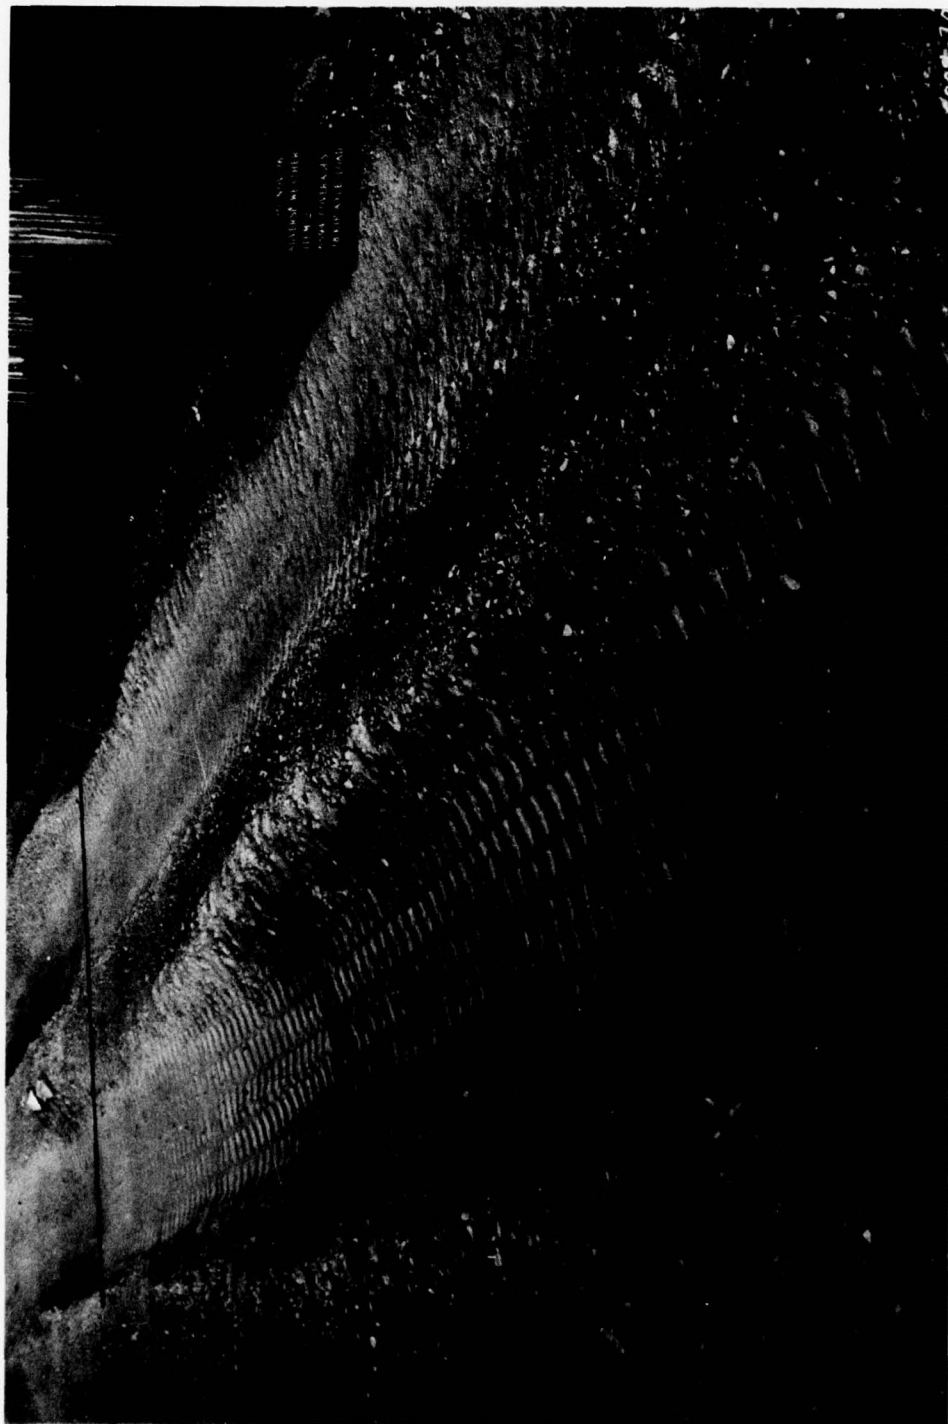
Photo 18. Item 2 after 6594 coverages

(Photo 18). After data collection and repairs were completed in the west wheel path, traffic was continued in the east wheel path. Photo 19 shows the east wheel path at failure after 9467 coverages.

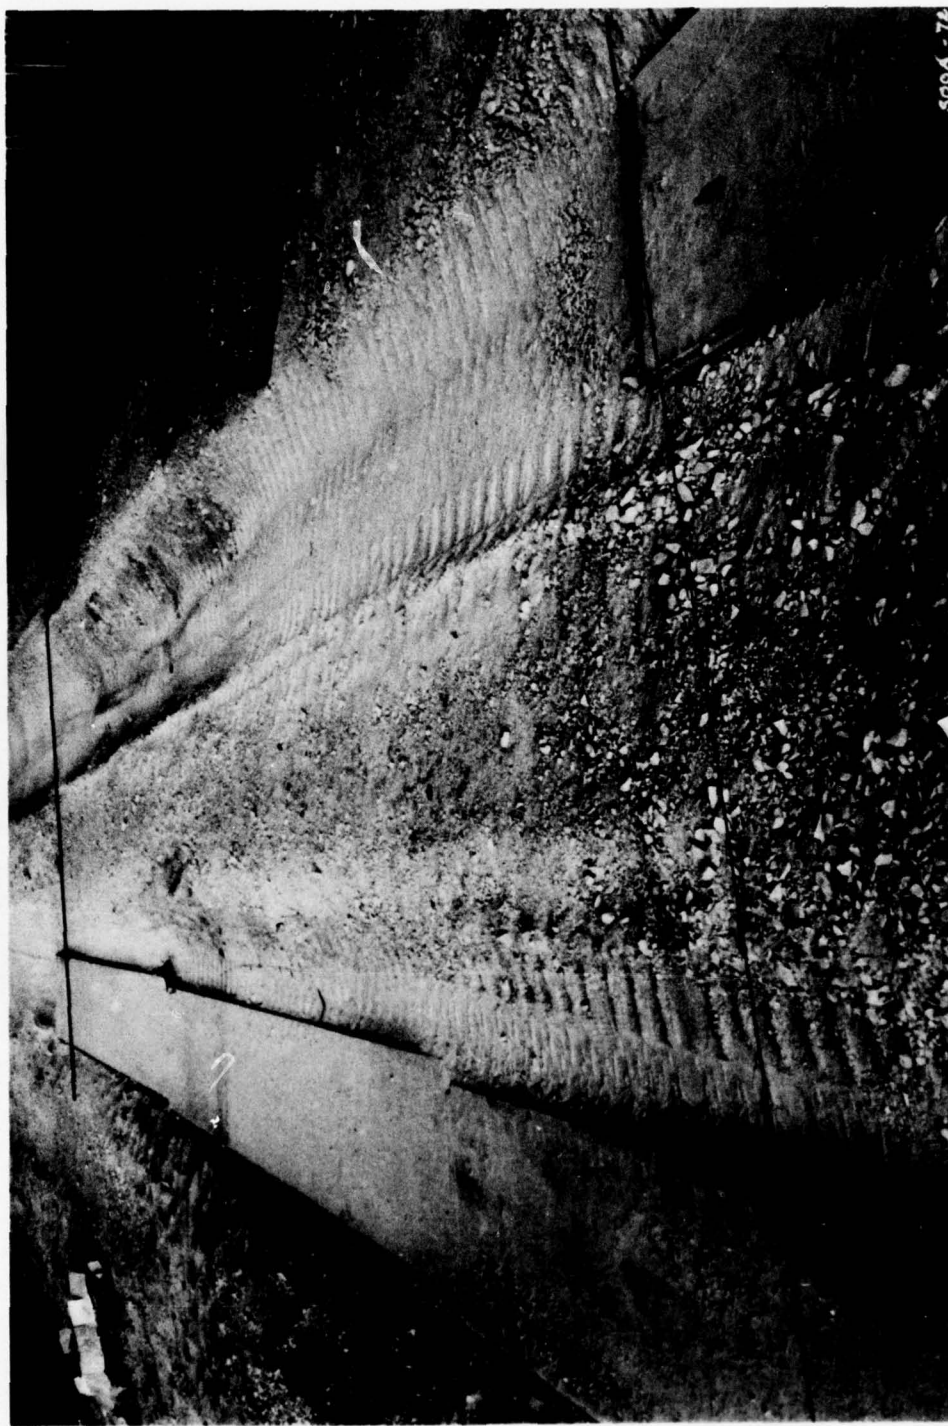
Photo 19. Item 2 after 9467 coverages

28. The normal tracking procedure was to allow test traffic to continue on an item until an 11-in. rut developed in a wheel path. The wheel path would be considered to have failed, and at this time test data would be taken. The rut would be filled with crushed stone and lined with a runner of landing mat (Photo 19) to allow traffic to continue on unfailed test items.

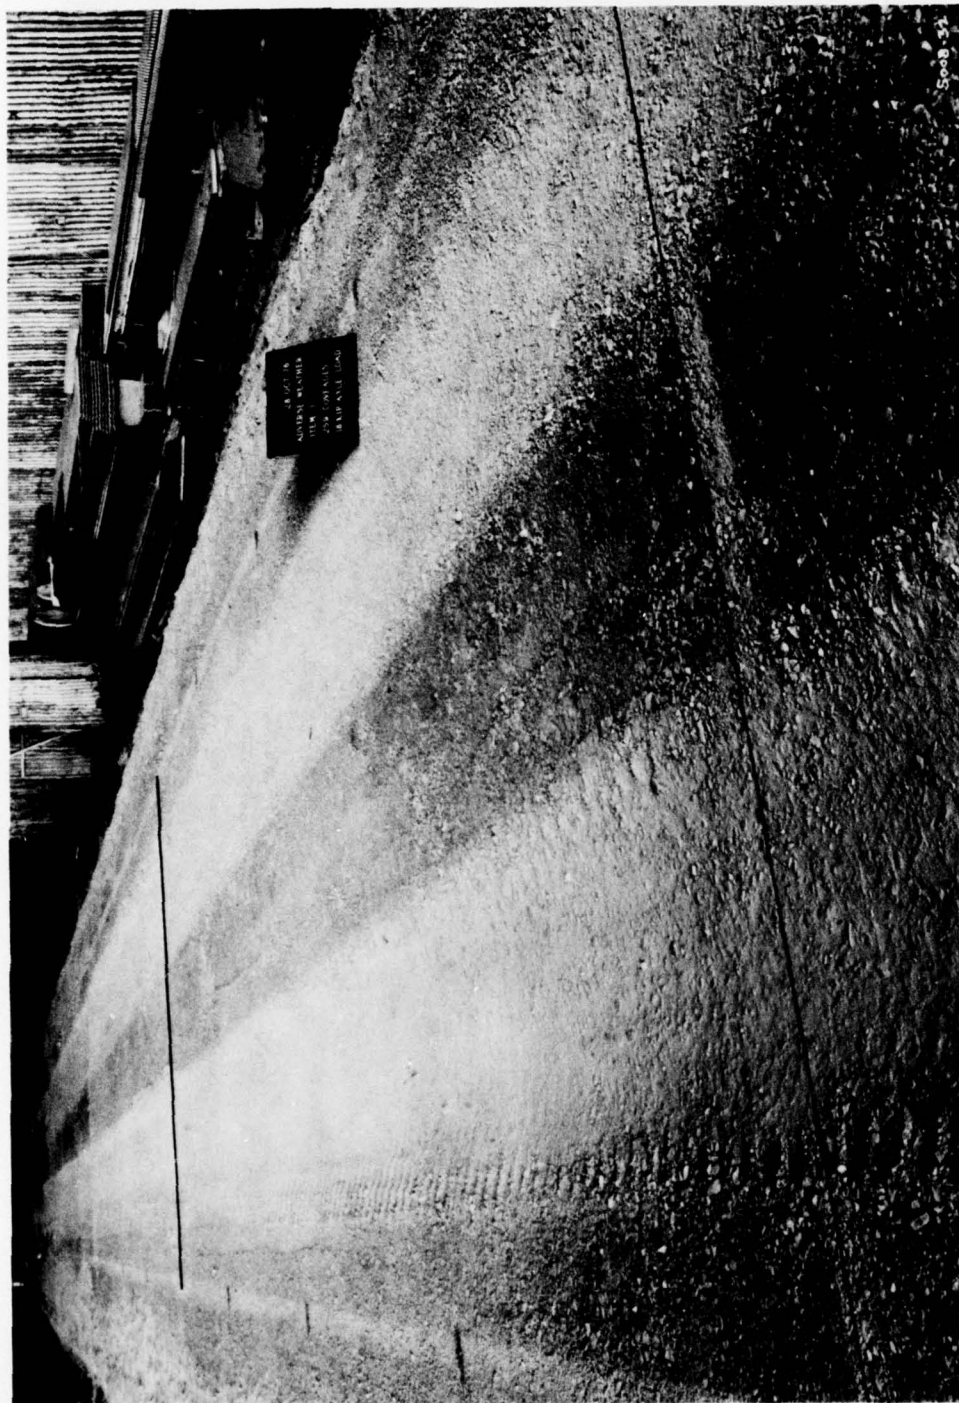
Photo 20. Item 3 after 259 coverages

34. The surface deflections under traffic loads were more noticeable in this item than in items 1 and 2. The general performance of this item was poor when compared to that of items 1 and 2. Photo 20 shows the item at 259 coverages with a 1.3-in. and 2.1-in. average rut depth in the east and west wheel paths, respectively. After 570 coverages, the average rut depth for the east wheel path was 1.8 in., while the average rut depth in the west wheel path had increased to 5.4 in. A spot failure was starting to develop in the center of the west wheel path (Photo 21). The west wheel path failed at 885 coverages; however, the average rut depth in the east wheel path was 2.3 in. (Photo 22). The east wheel path failed at 2824 coverages. Plate 5 shows typical cross-section data for this item.

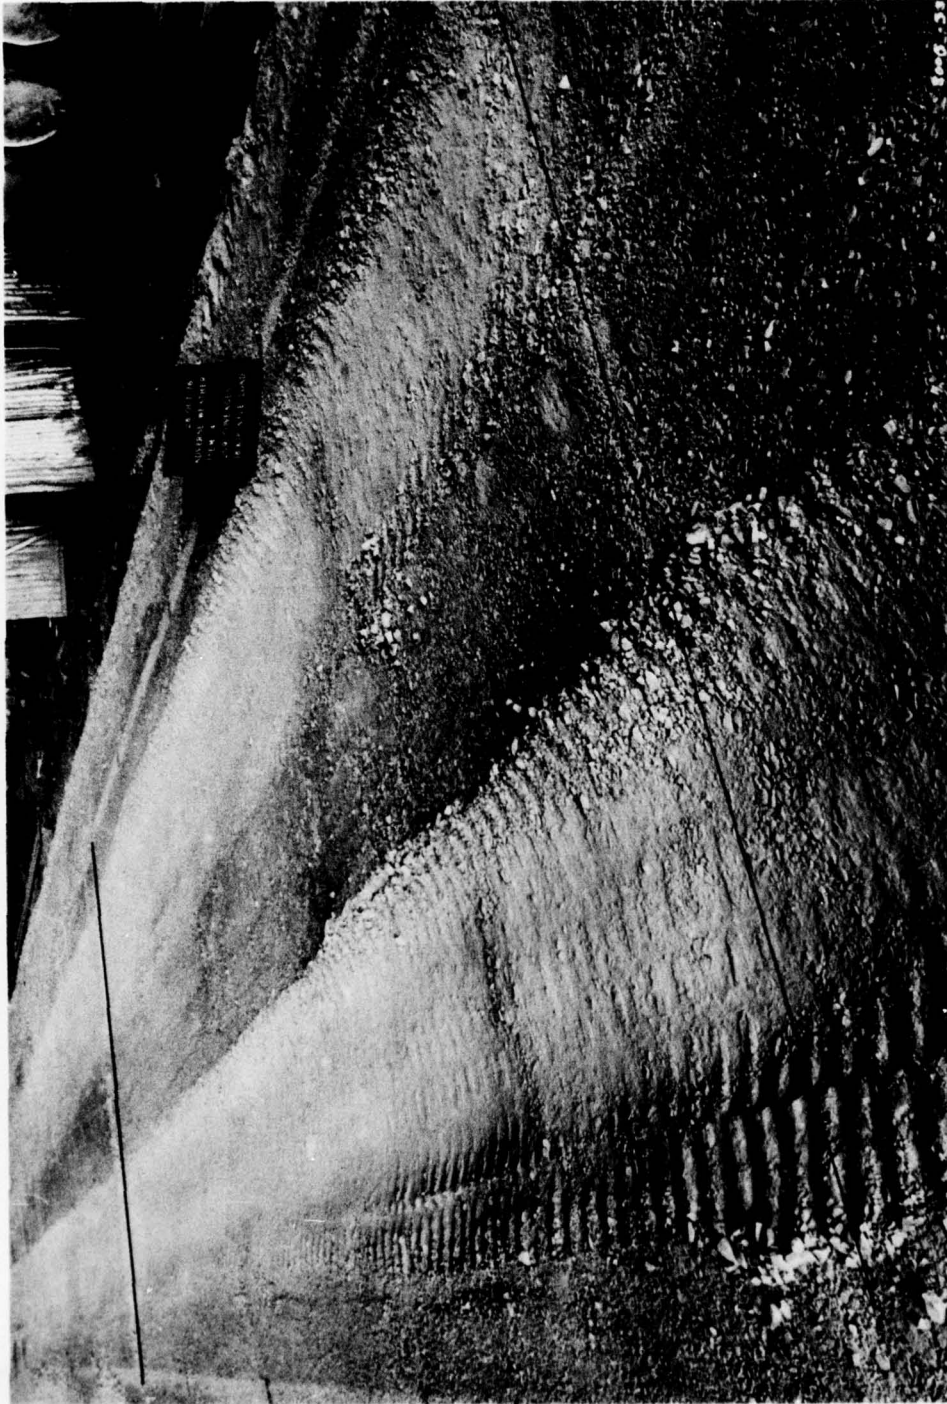
Photo 24. Item 4 after 259 coverages

36. The performance of this item was poor. Both wheel paths developed 11-in. ruts after 1907 coverages. Photo 24 shows the item after 259 coverages with an average rut depth of 3.3 in. in the east wheel path (mortar sand) and 2.2 in. in the west wheel path (concrete sand). The average rut depths were 5.5 in. and 3.6 in. in the east and west wheel paths, respectively, after 528 coverages. After 1000 coverages, the average rut depth was 7.9 in. in the east wheel path and 5.5 in. the west wheel path. Photo 25 shows the surface condition of the item at failure after 1907 coverages.

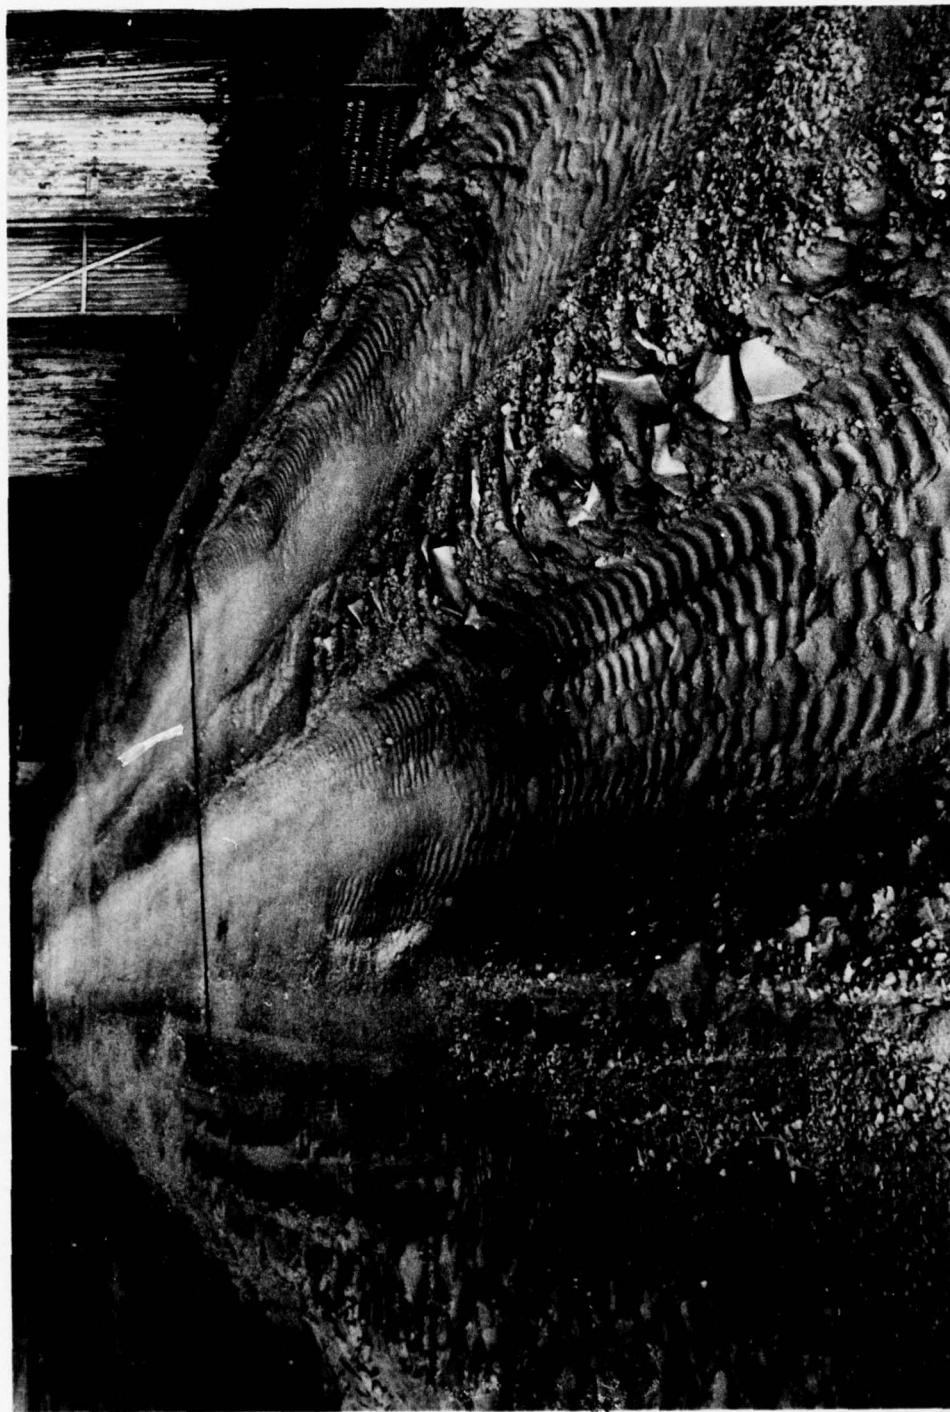
Photo 25. Item 4 after 1907 coverages

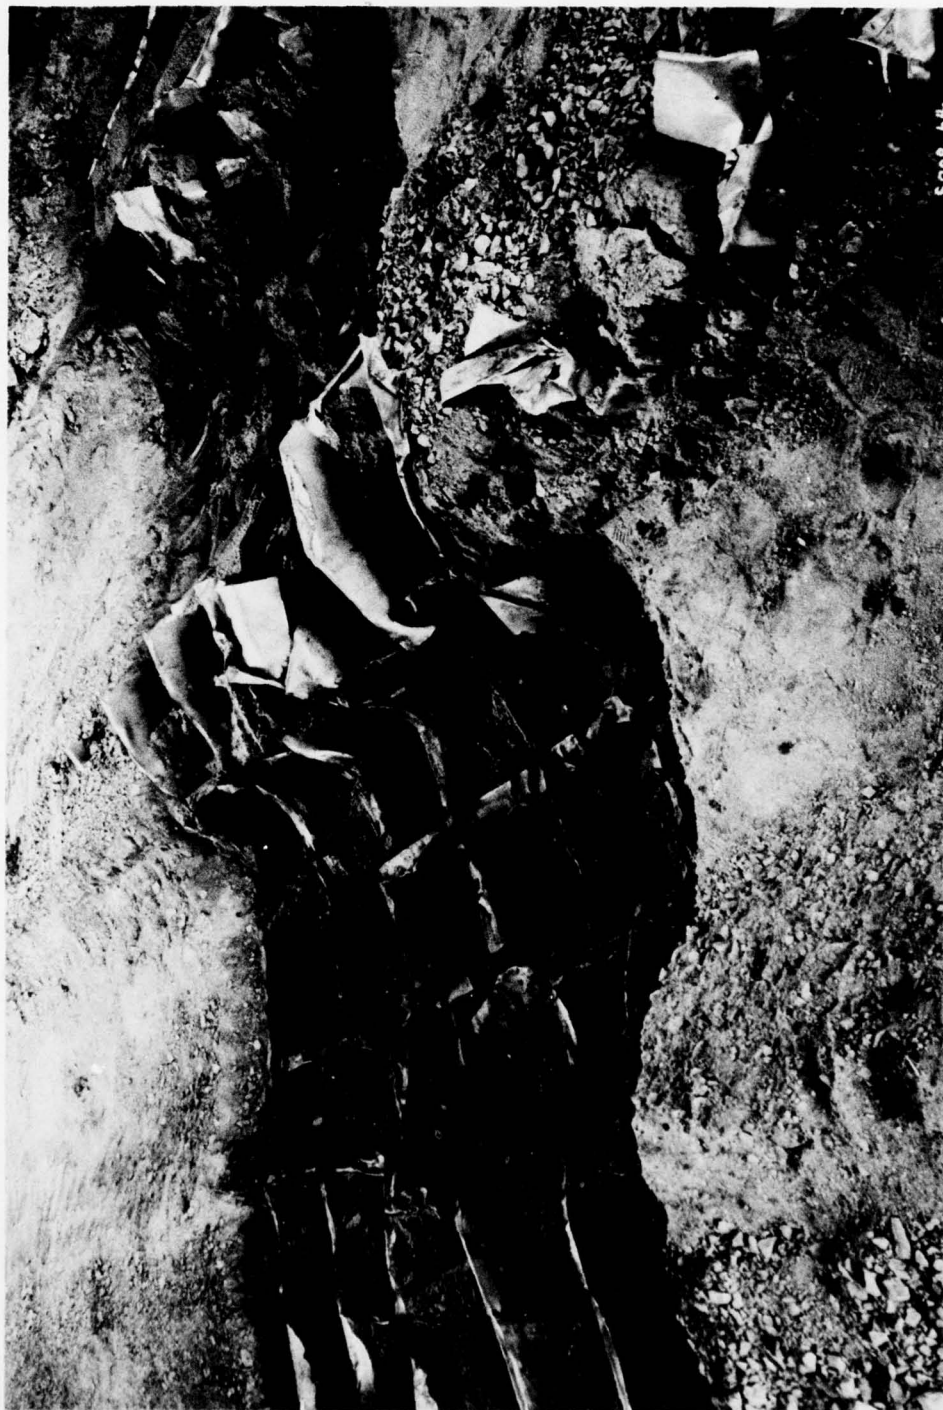
Photo 26. Damaged grids of item 4 after 1907 coverages

37. Approximately 3 to 4 in. of sand was displaced from the grid layer inside the wheel paths during traffic. The tops of the grids were bent by traffic as the sand was being displaced (Photo 26). Photo 27 shows the condition of the T-16 membrane after the grid layer was removed. The grids had cut holes in the T-16 membrane at numerous locations. The surface of the subgrade is shown in Photo 28; the rut and upheaval shown are typical to that which occurred in items 1, 2, and 3. Typical cross-section data for this item are presented in Plate 6.
